**Built Heritage Sub-Committee / Sous-comité du patrimoine bâti  
April 12, 2018 / 12 avril 2018**

**File Number: ACS2018-PIE-RHU-0009**

**SUBJECT: Application to permit the demolition of the Ugandan High  
Commission, 231 Cobourg Street, a property located in the Wilbrod  
Laurier Heritage Conservation District and application for new  
construction on the same site**

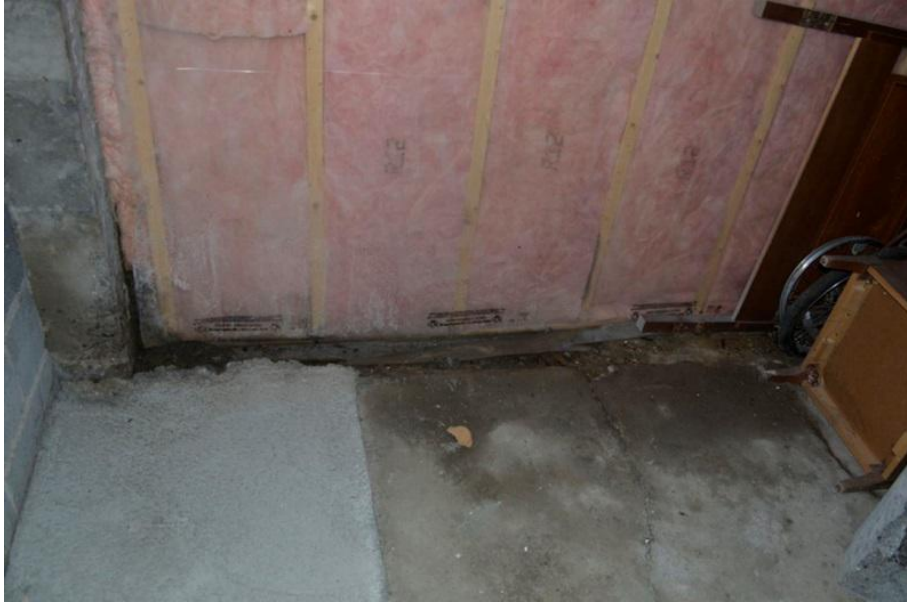
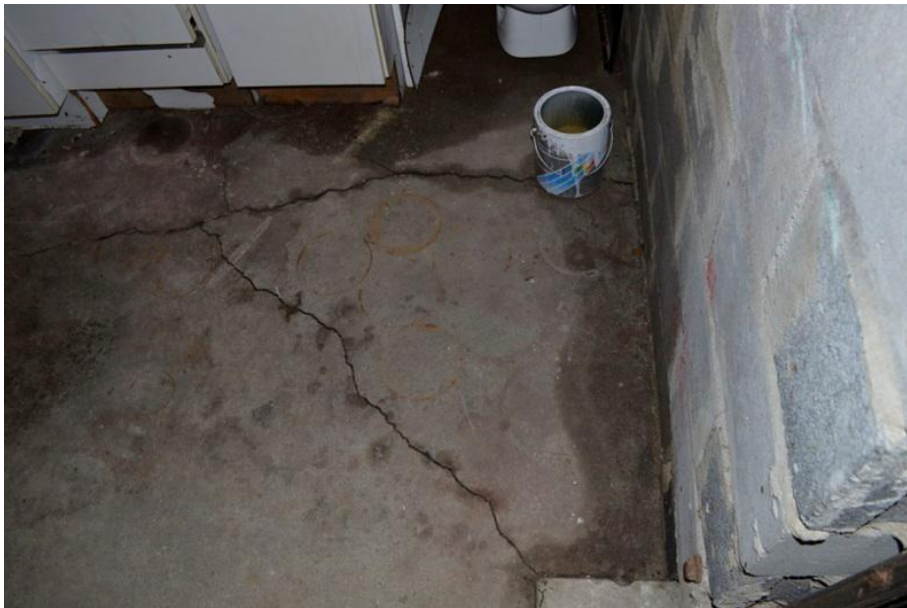
**Document 4 – Photographs showing structural damage**

Cracks in floor slab

The current Ugandan High Commission is a flat-roofed, rectangular, two-storey, red brick structure with brick quoins and a modified cornice with simple brick detailing. The front door is symmetrically placed and features a door surround with a broken pediment. There is an octagonal window above the door (see current photographs, Document 3). The building has experienced cracking due to differential settlement in recent years. (For photographs showing damage, see Document 4)

The initial 2013 engineering report and assessment of the structure by the Paterson Group, was undertaken when the building was still occupied by the staff of the Ugandan High Commission. It noted structural damage including the cracking of the slab on grade, foundation walls, masonry walls, uneven floors and damaged interior walls. The accompanying 2013 Geotechnical Assessment by the Paterson Group attributed the structural damage to be "related primarily to settlement associated with moisture depletion of the underlying clay soils," explaining that:

Heritage staff reviewed the reports from three different engineering firms, included here as Documents 6 to 10, and toured the structure and concur with the findings of the engineers that the building has undergone significant settlement and cracking, concluding that it was not practical to retain it.

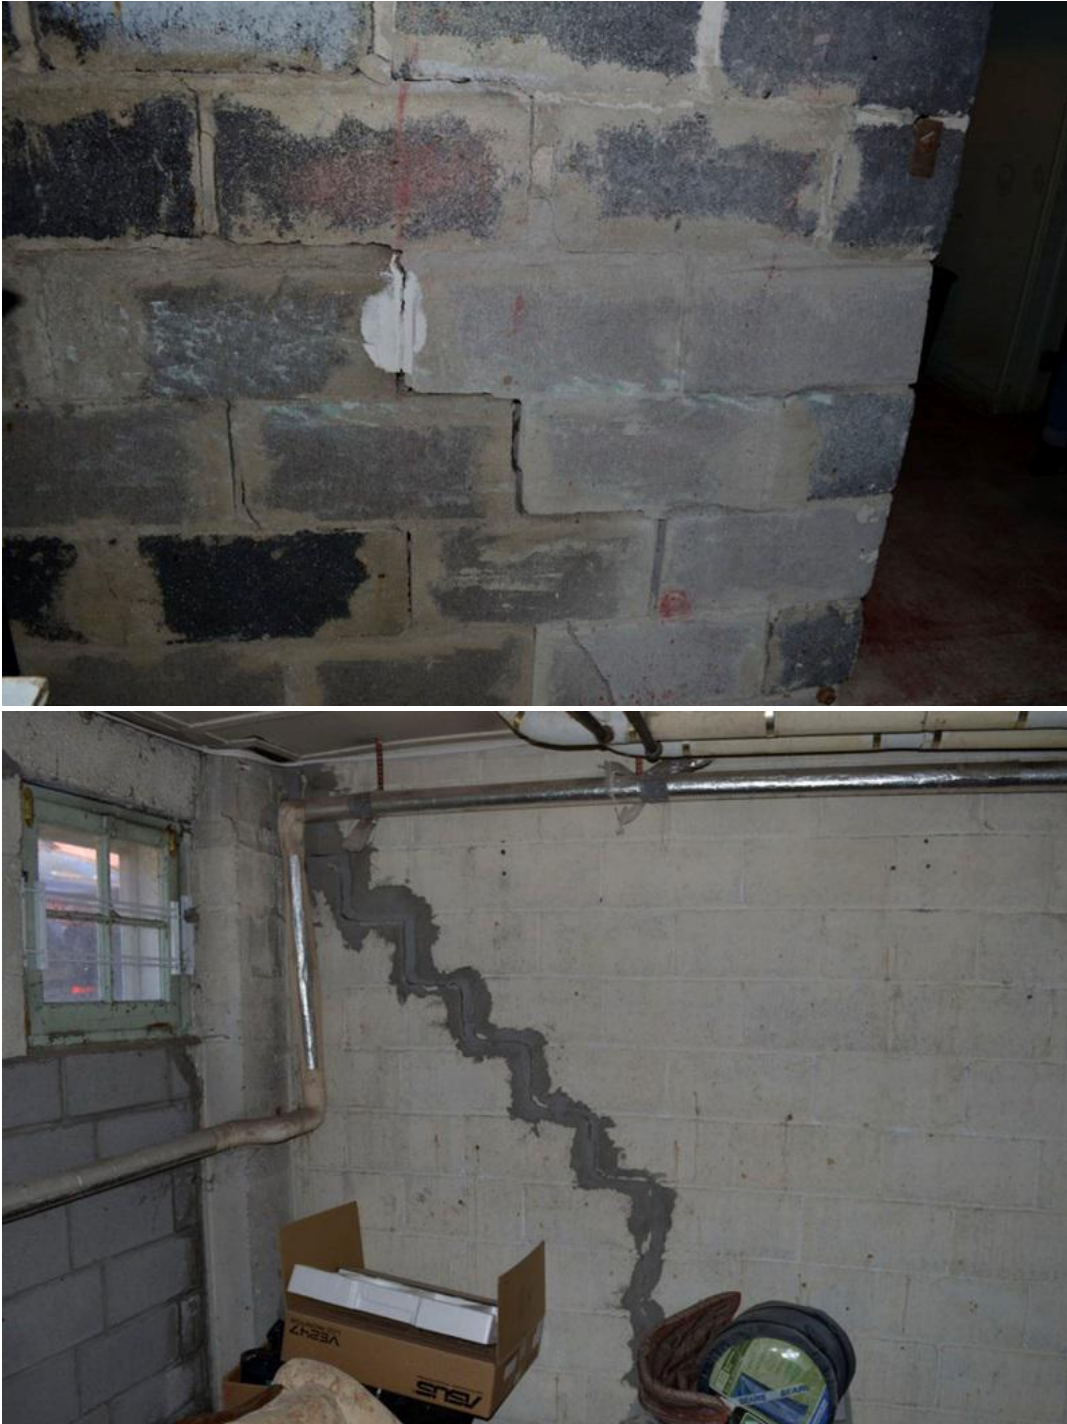
Cracking in foundation wall

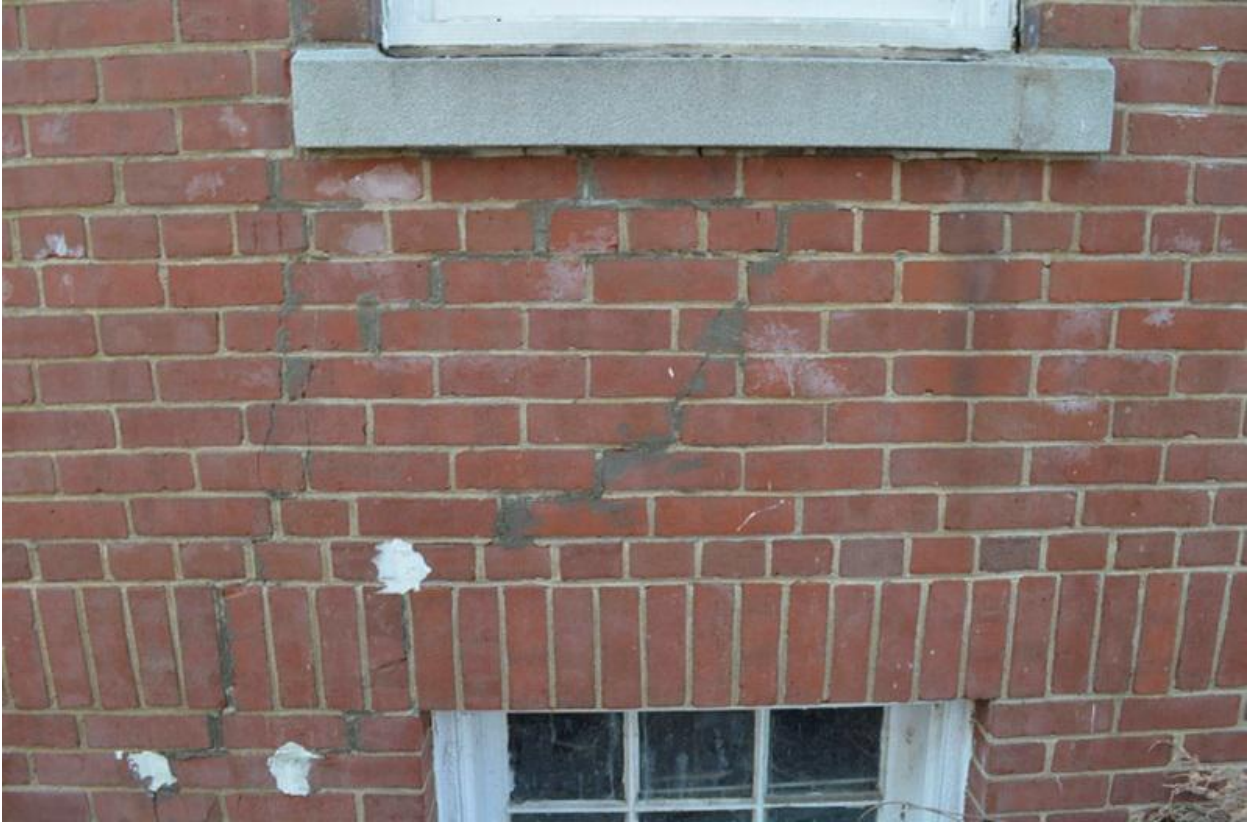
Exterior cracking

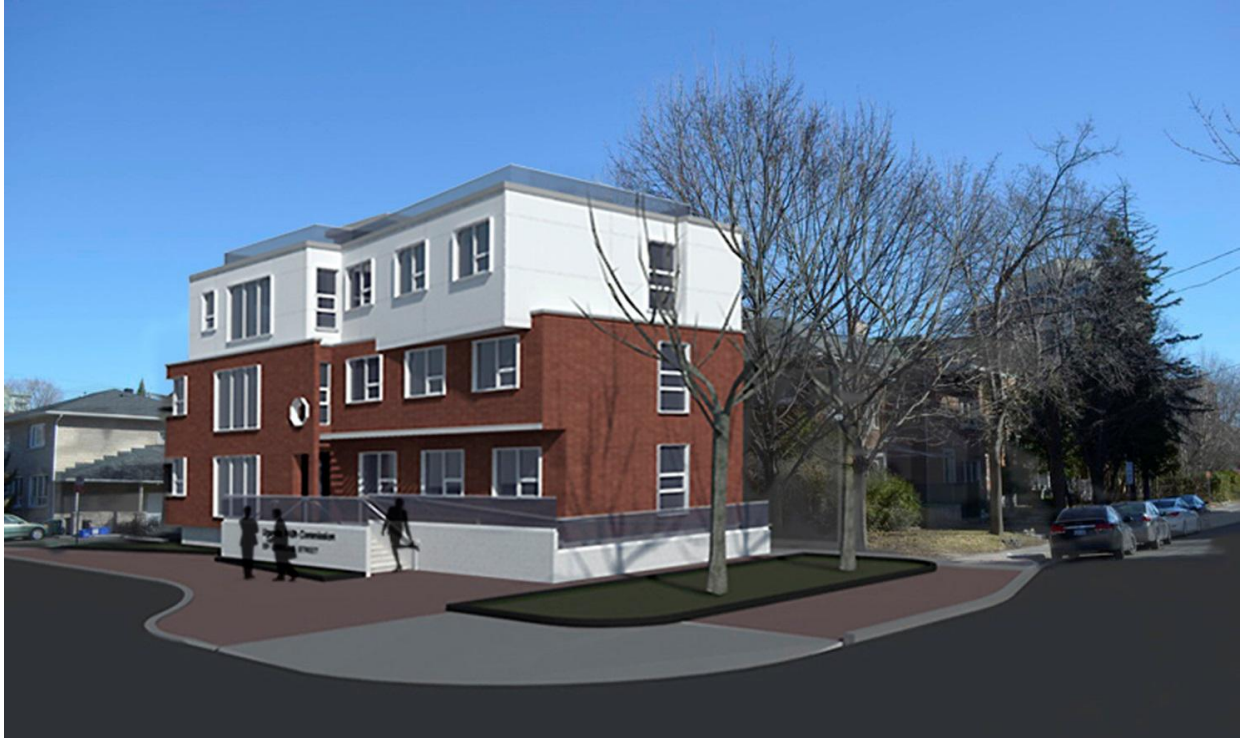
**Document 12 – Before and after images of proposed high commission**

Front and south façades as originally presented.

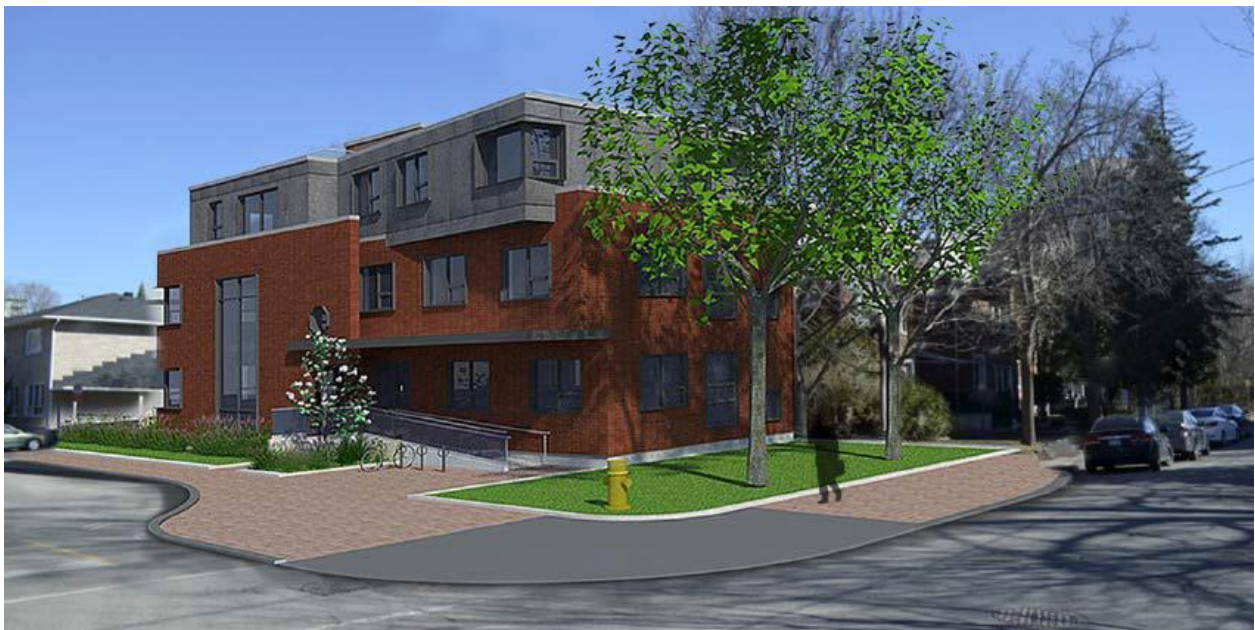
Front and south façades after revisions undertaken in consultation with heritage and planning staff.

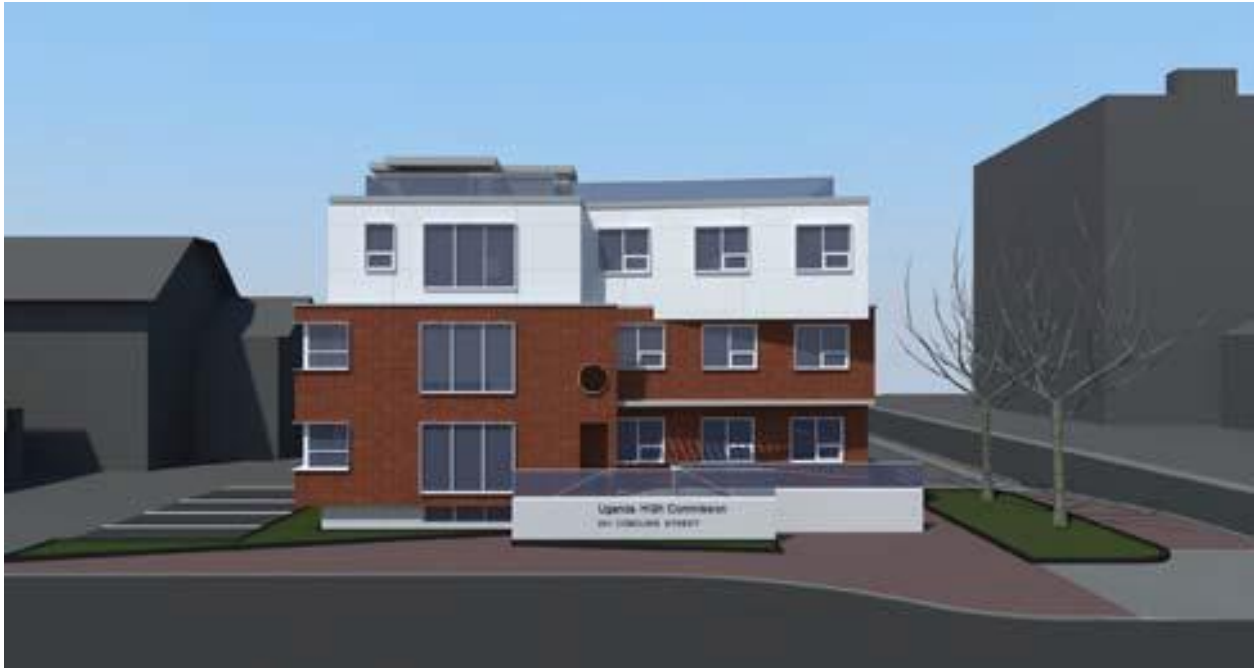
Front (west) façade, before revisions.

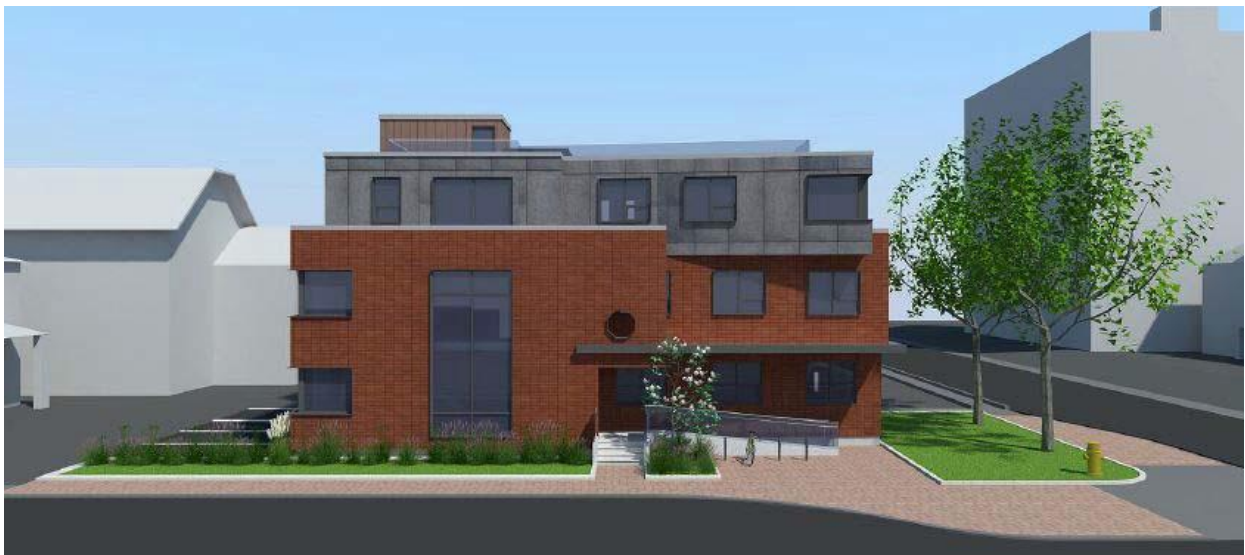
Front façade after revisions undertaken as a result of consultation with heritage, planning and urban design staff.

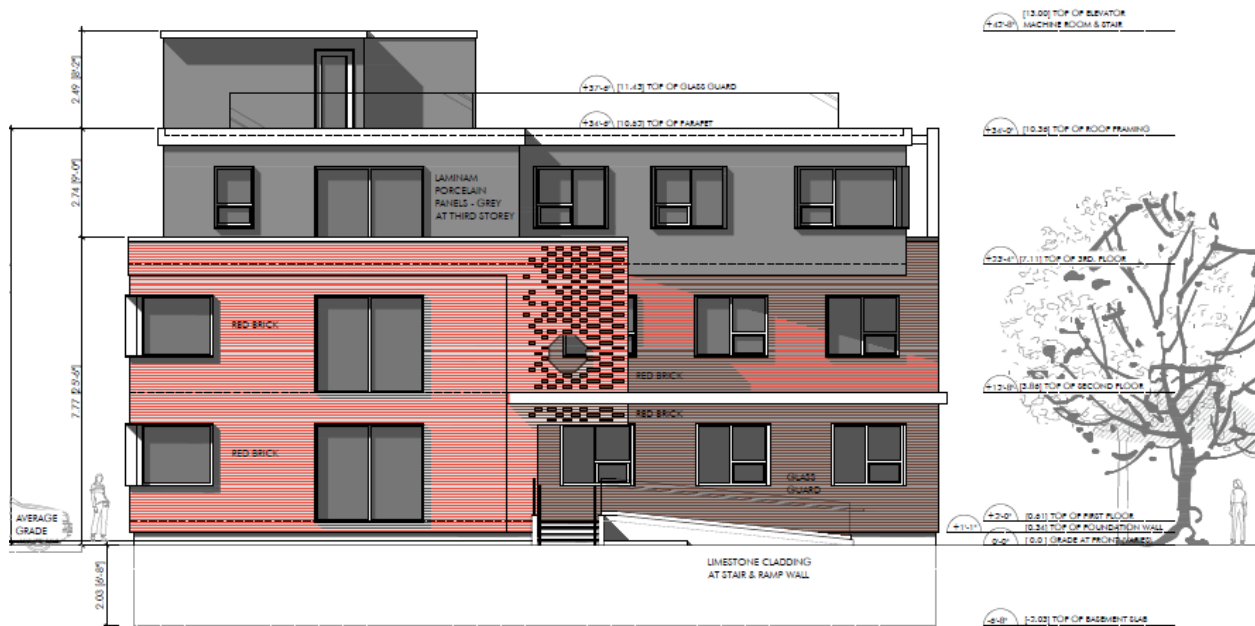
Front façade after revisions undertaken as a result of the February 8 Built Heritage Sub-Committee motion. Changes include the separation of the two front windows into two separate units, the introduction of a stylized cornice and quoins and the removal of bricks in the screening wall to create a brise-soleil.

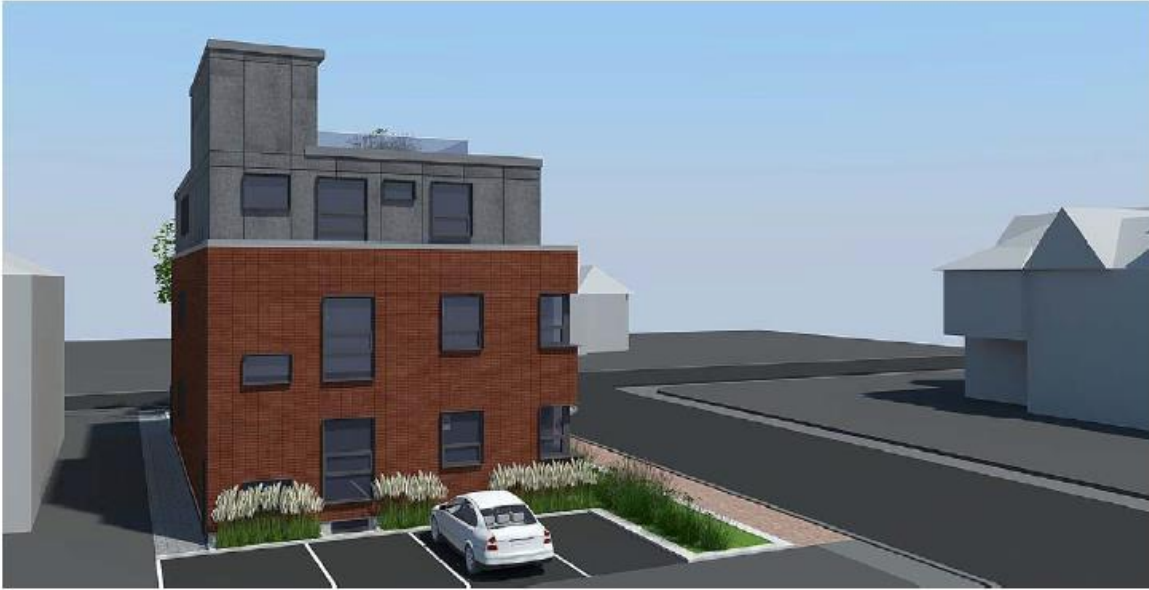
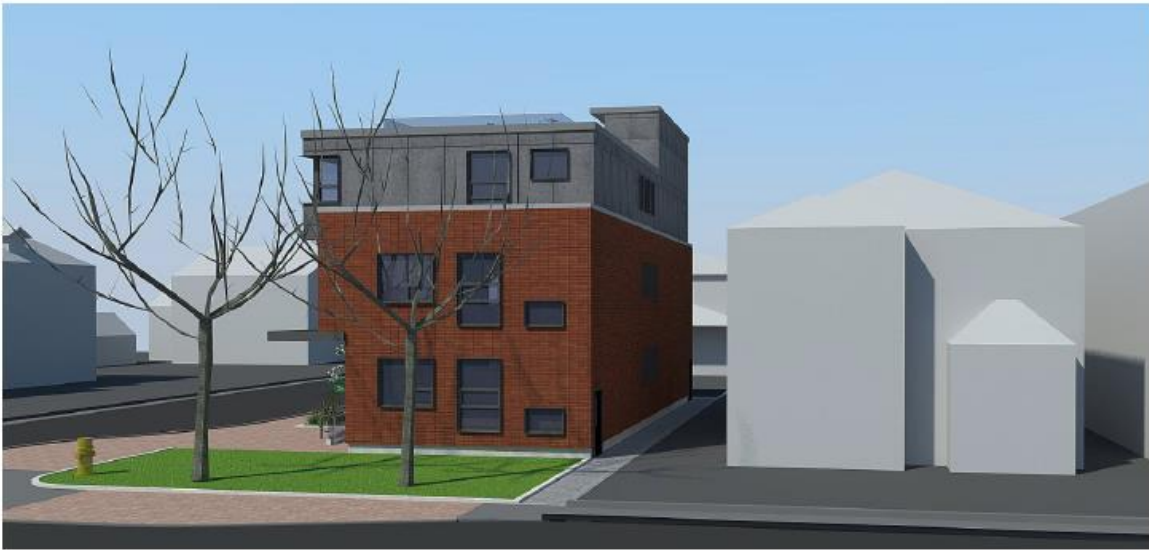
North and south façade after initial revisions. Differences include more windows on south façade to reflect residential fenestration patterns along Wilbrod Street, increased inset of third floor, further inset of rooftop terrace.

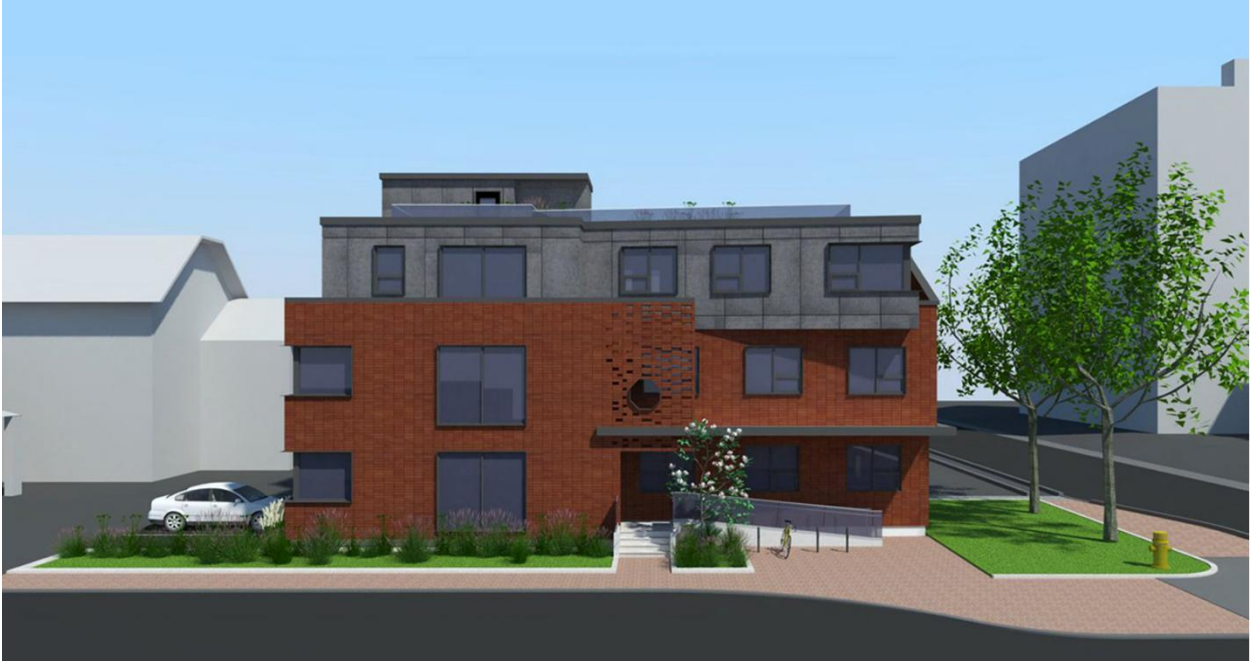
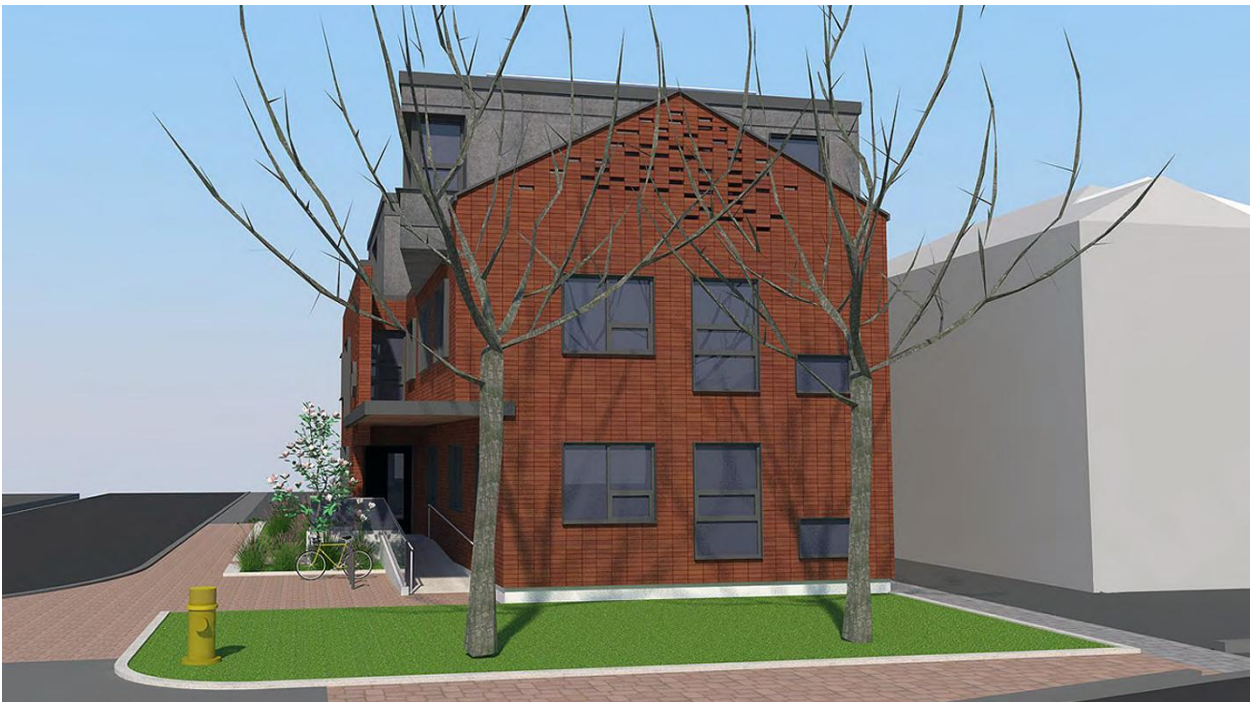
North and south façades after revisions undertaken as a result of the February 8 BHSC motion. Changes include the extension of the new stylized cornice line to the north façade, the extension of the south wall upwards to create a gabled parapet, with bricks removed to form a brise-soleil that will allow light to penetrate to the third floor windows behind.
