**Built Heritage Sub-Committee / Sous-comité du patrimoine bâti
8 February 2018 / 8 février 2018**

File Number: ACS2018-PIE-RHU-0003

**SUBJECT: Application to permit the demolition of the Ugandan High
Commission, 231 Cobourg Street, a property located in the Wilbrod
Laurier Heritage Conservation District and application for new
construction on the same site**

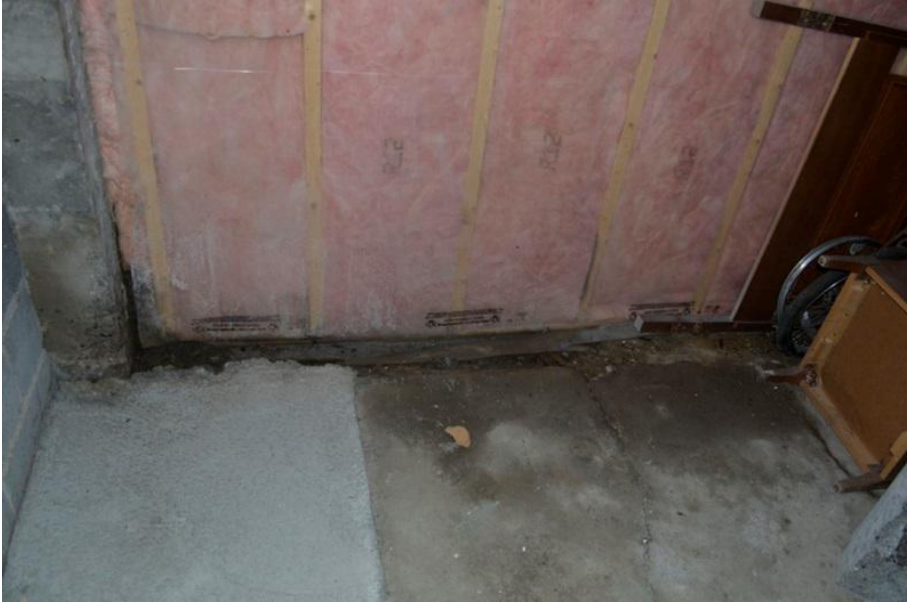
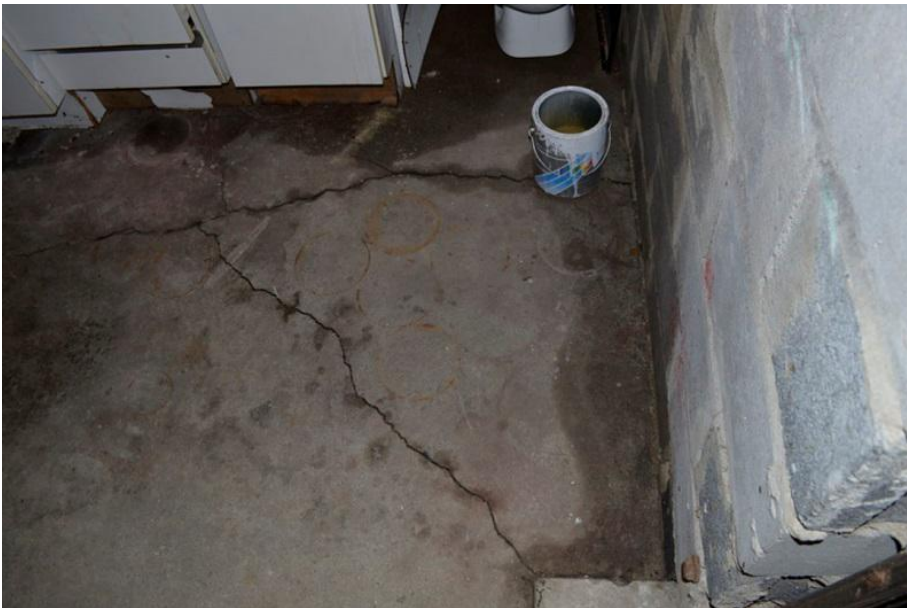
Document 5 – Photographs showing structural damage

Cracks in floor slab

In 2014, the Ugandan High Commission was declared unsafe due to cracking caused by ongoing differential settling of its foundations and walls and, after about 20 years serving as the high commission, its occupants abandoned the building. In the years leading up to the vacating of the building, efforts were made to repair the cracking and shifting of the structure. However, because of the presence of unstable soils and the character of the building, none of the solutions to the structural damage to the building solved or halted its ongoing deterioration. Since it was abandoned, further cracking and damage to the interior has occurred (for photographs of cracked foundations, please see Document 5, for Engineer's Report, please see Document 6). The cost to complete the repair of the structure is very high, and given that there are other issues related to the building such as universal accessibility and its ability to serve the needs of a high commission in the twenty-first century, the Government of Uganda decided to apply to demolish and replace the existing structure.

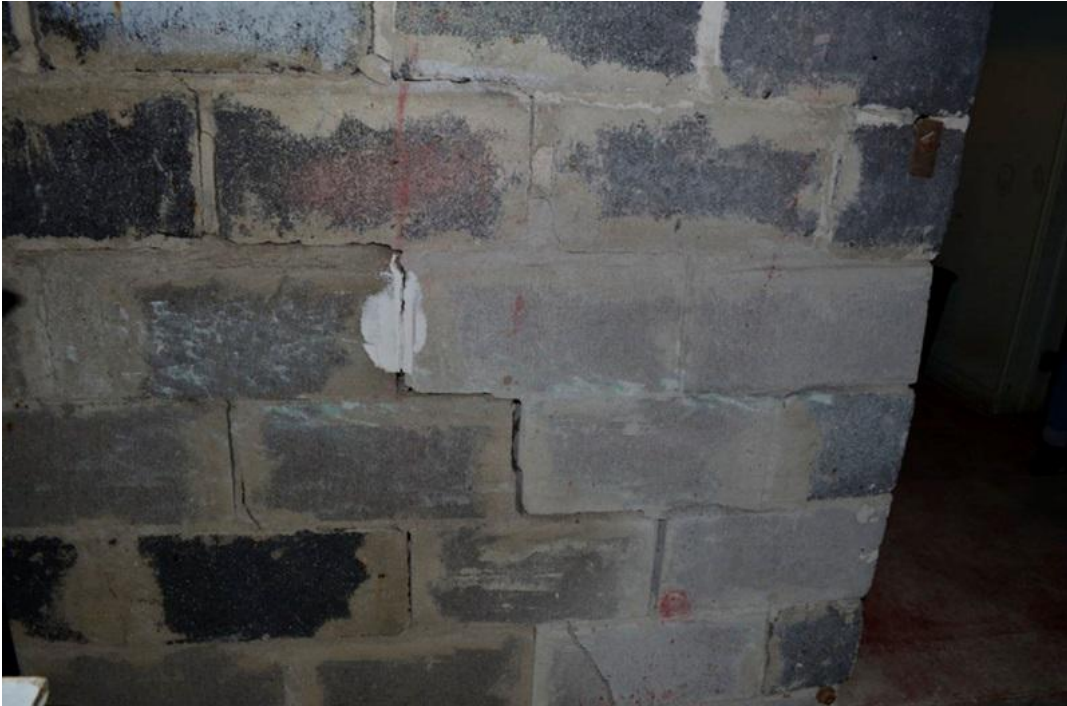
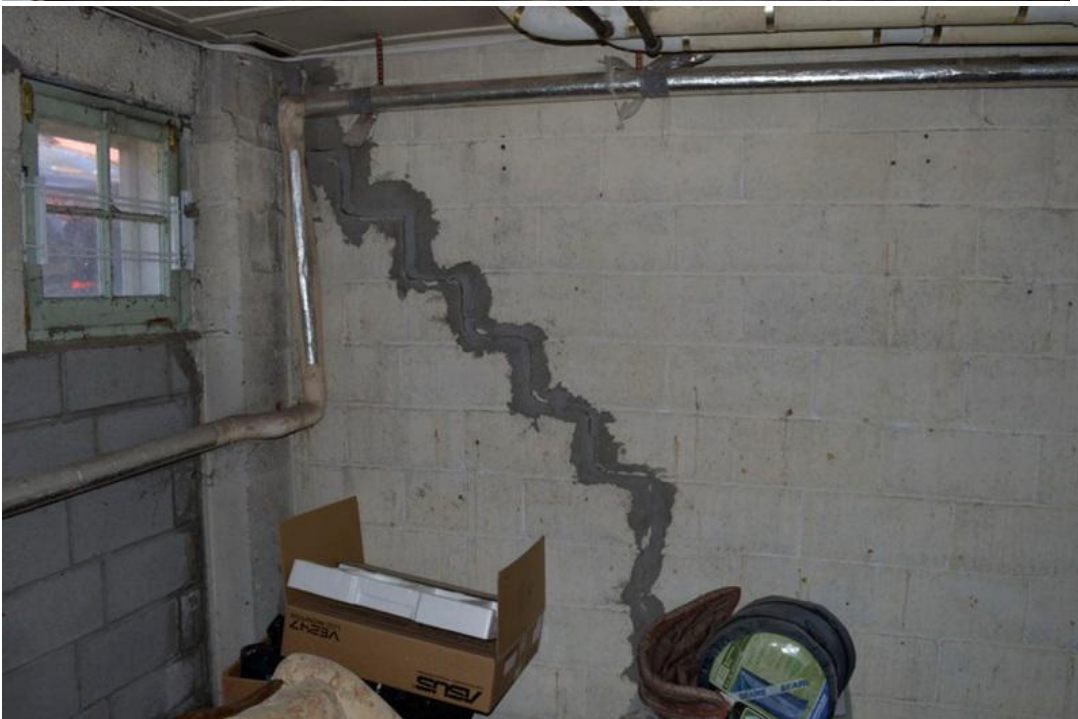
Cracking in foundation wall

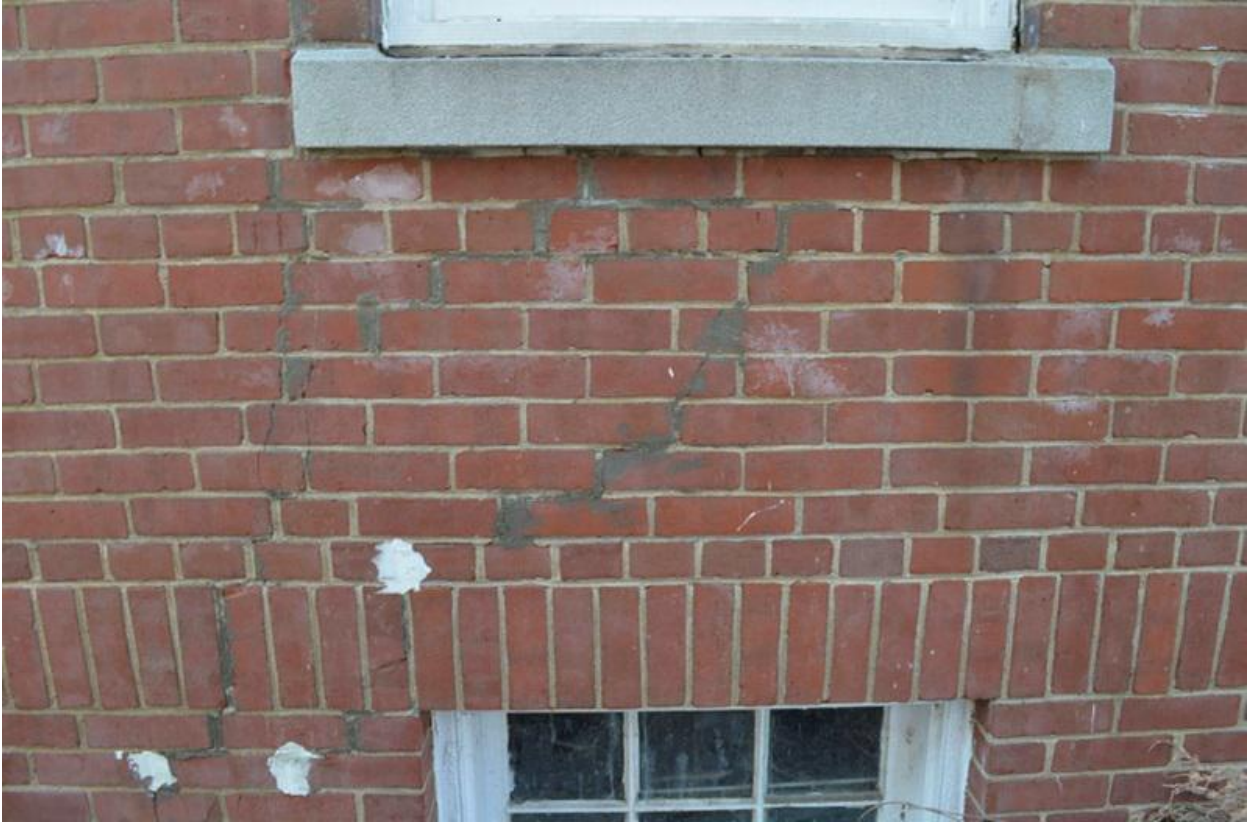
Exterior cracking

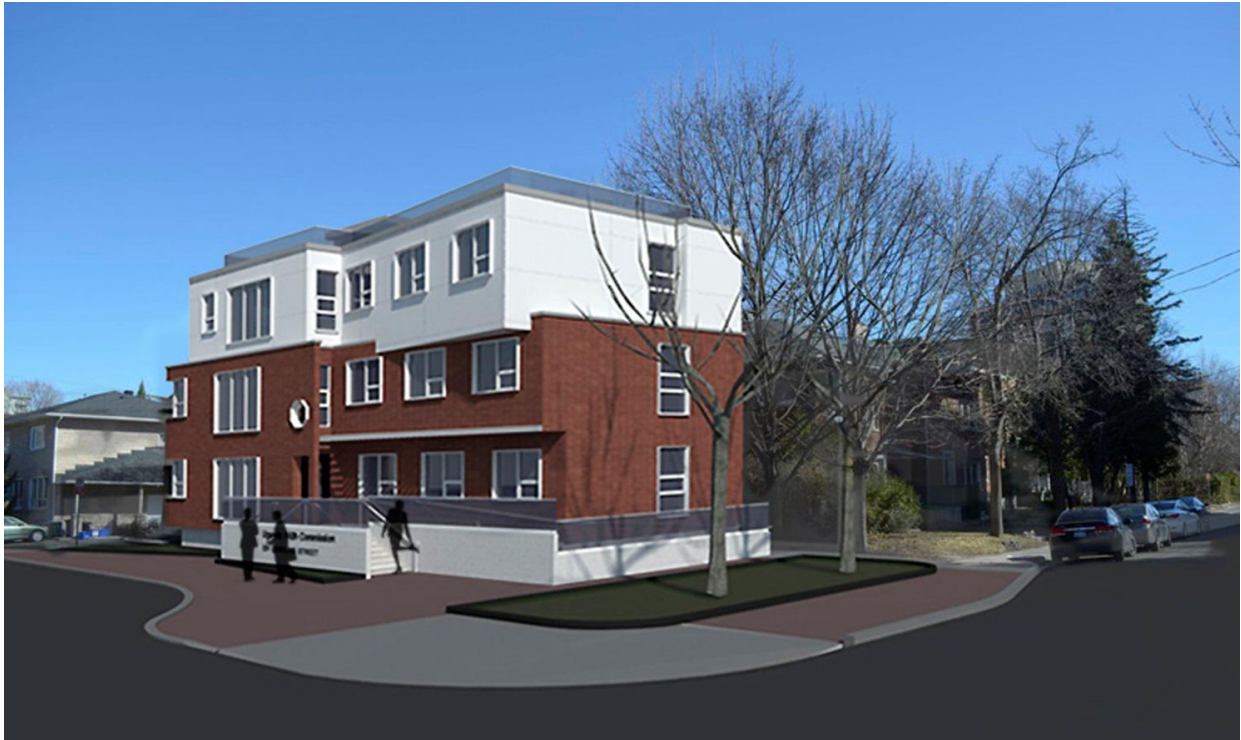
Document 7 – Before and after images of proposed high commission

Front and south façades as originally presented.

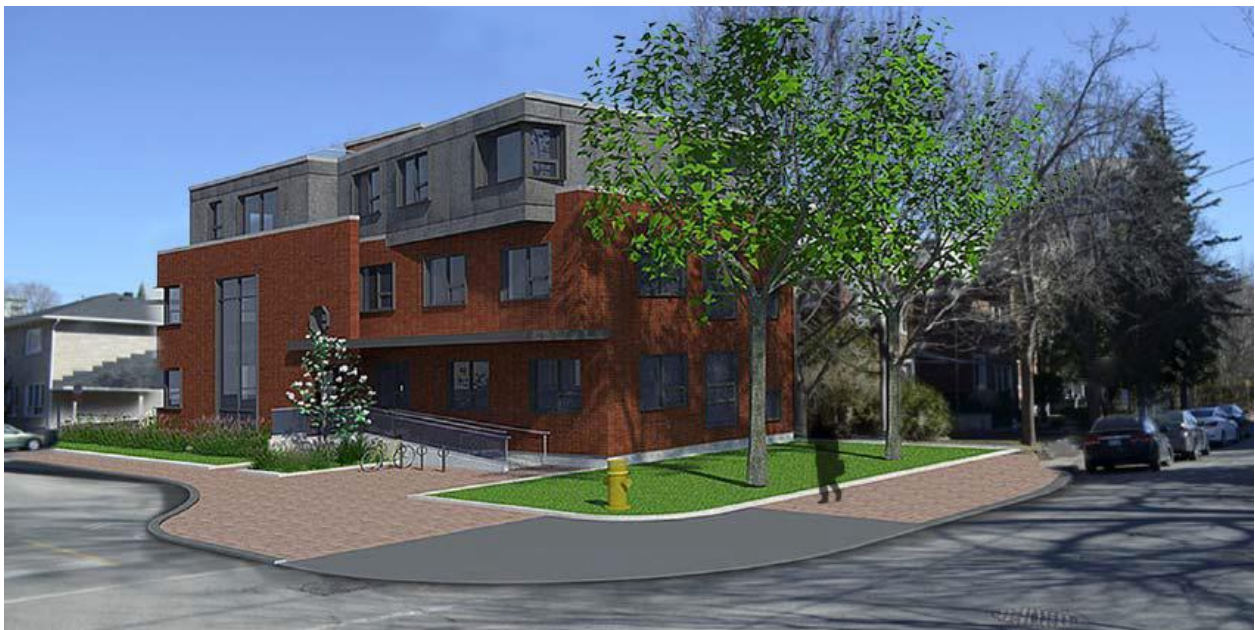
Front and south façades after revisions undertaken in consultation with heritage and planning staff.

As a result of these discussions, the following changes to the design as submitted were undertaken; The height of the building was lowered to 10.44 metres from 10.89 metres, the handicapped ramp was shortened and relocated to the front (west) façade, the colour of the recessed third floor changed from white to grey, the third floor was stepped back one metre, the rooftop terrace was setback 1.5 metres from the roof edge, new landscaping, including a small front garden, and reduced signage that is residential in character was introduced on the Cobourg Street façade and more windows were added onto the south façade.

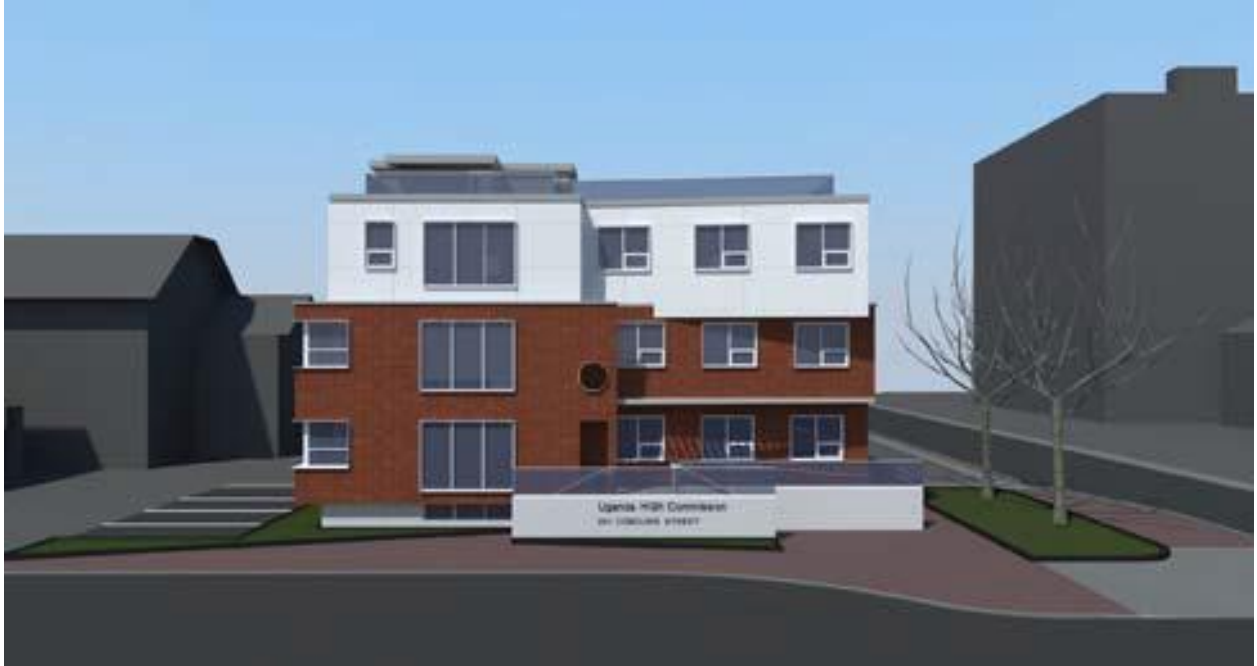
Front (west) façade, before revisions.

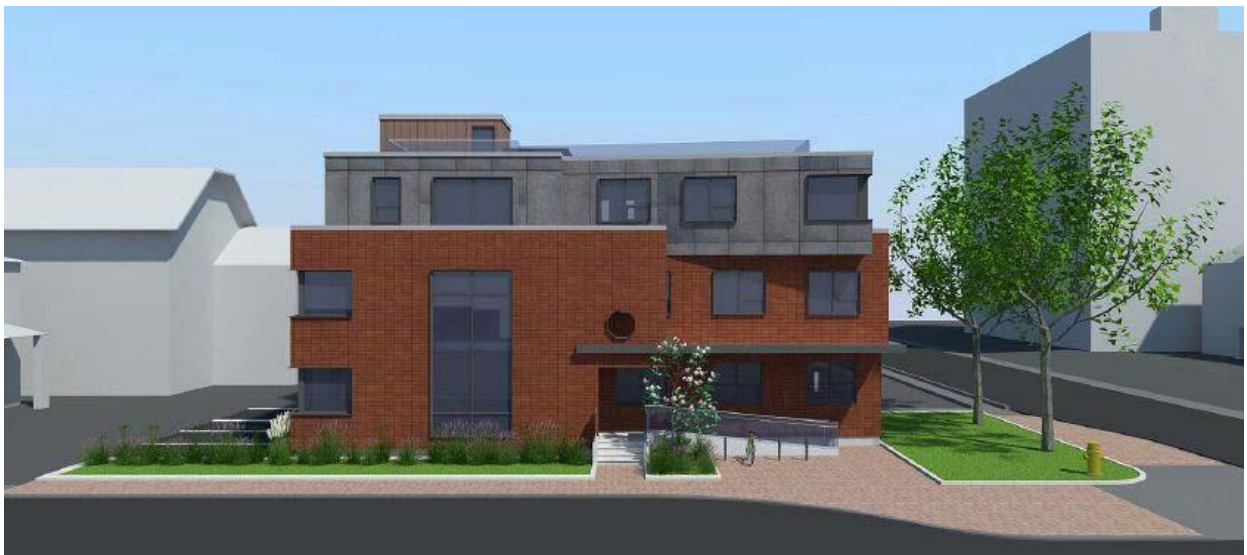
Front façade after revisions

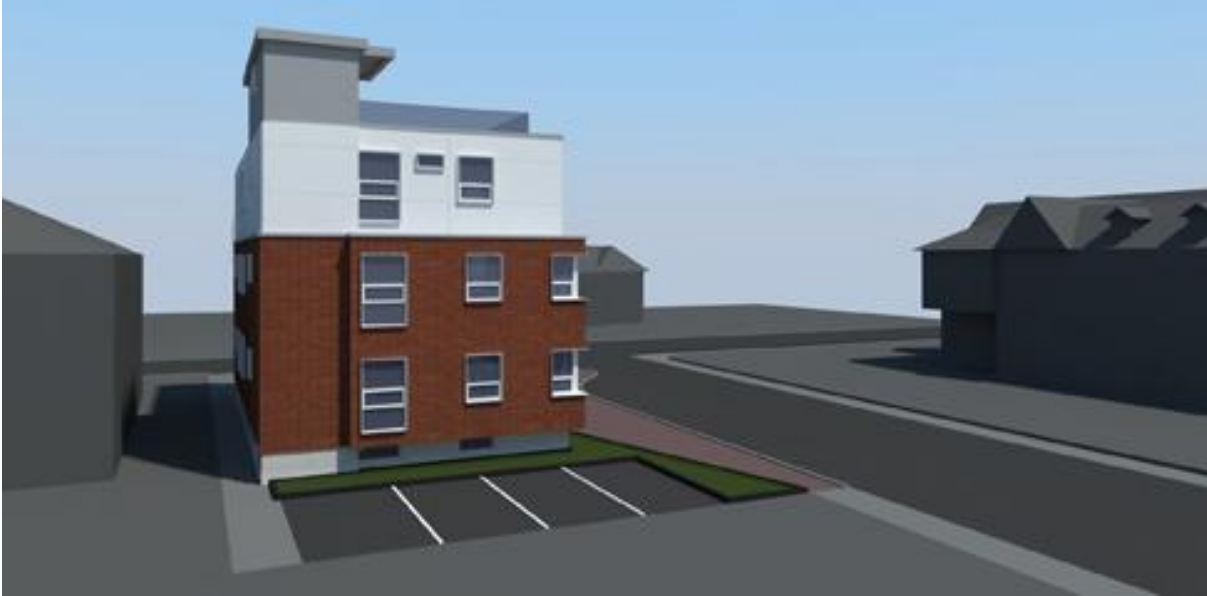
North façade, before revisions.

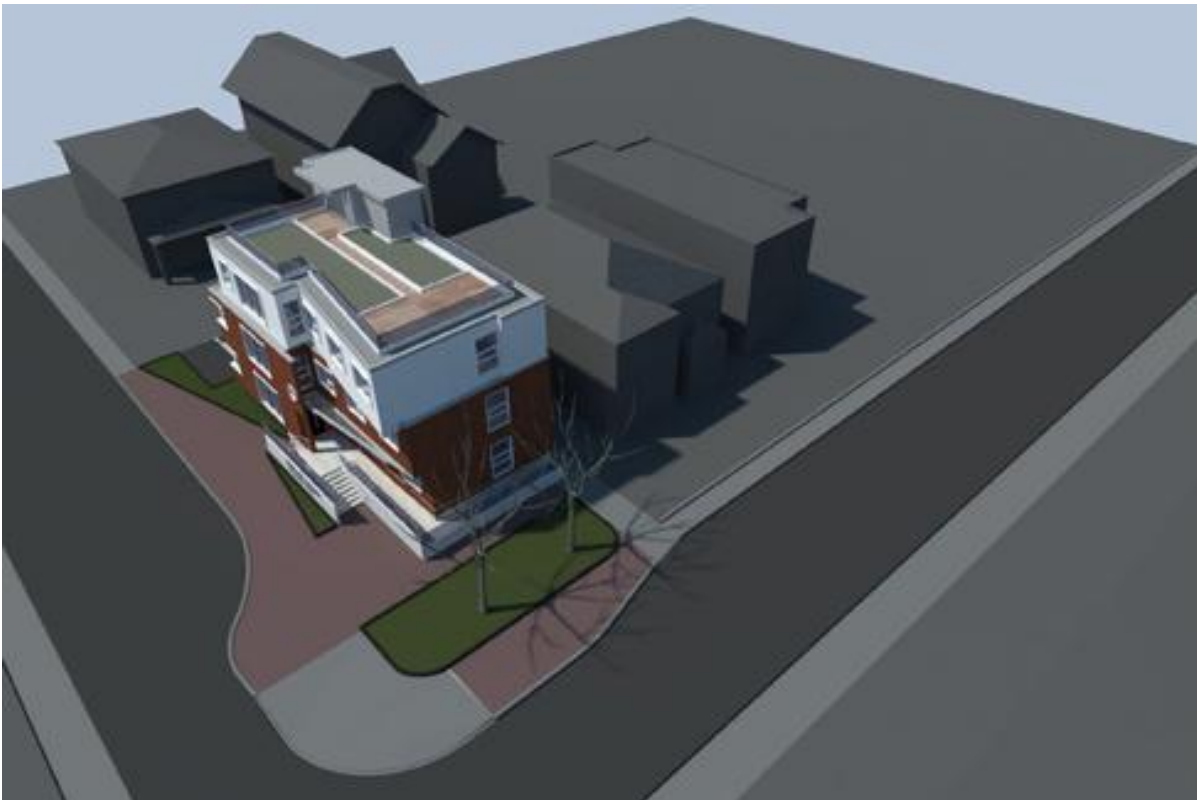
South façade before revisions.

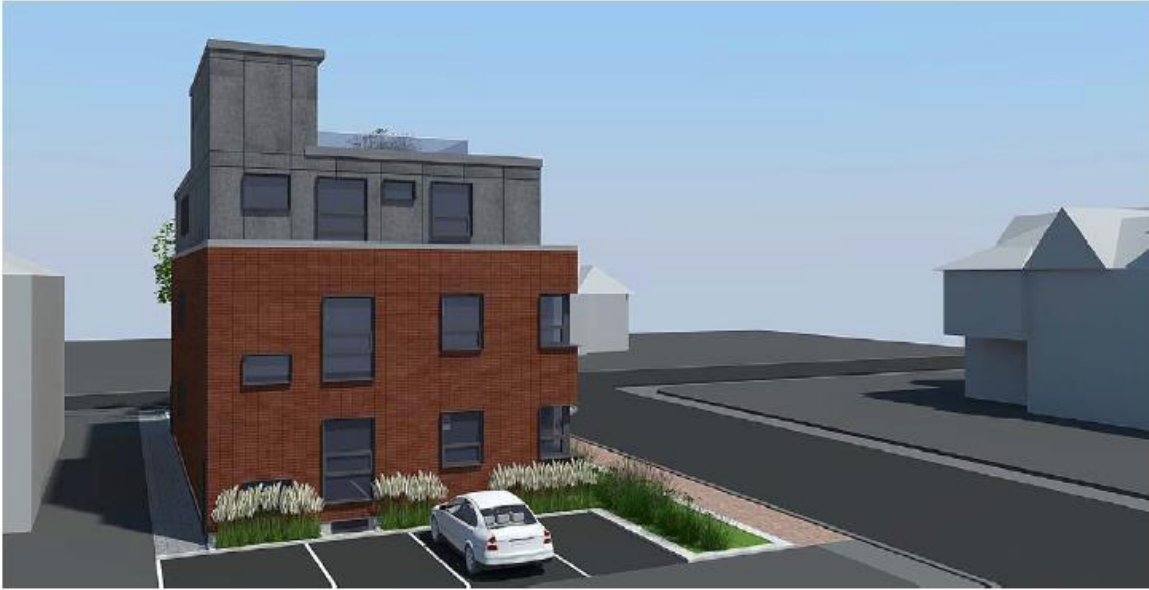
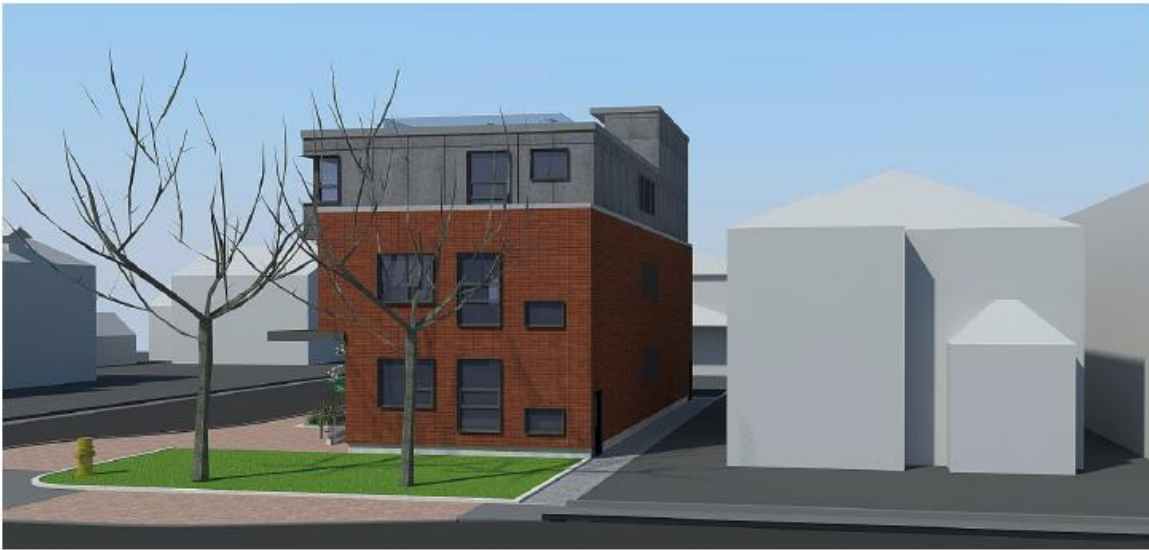
North and South façade after revisions. Differences include fewer windows on east façade, more windows on south façade to reflect residential fenestration patterns along Wilbrod Street, increased inset of third floor, further inset of rooftop terrace.
